Restoration of the Lincoln Memorial Murals

In 1995 and 1996, two decorative murals by the artist Jules Guerin were restored at the Lincoln Memorial in Washington, DC. The murals, painted between 1917 and 1918, were in such poor condition that they were easy to miss when visiting the memorial. They are very high off the floor (37 feet) and were obscured by the dirt and the damage of 76 years of exposure to the elements. The restoration was one component of a multi-million dollar preservation effort sponsored by the National Park Service (NPS) for the memorial as a whole. It was completed by the firm of Cunningham-Adams Fine Arts Painting Conservation of Sandy Hook, Connecticut.

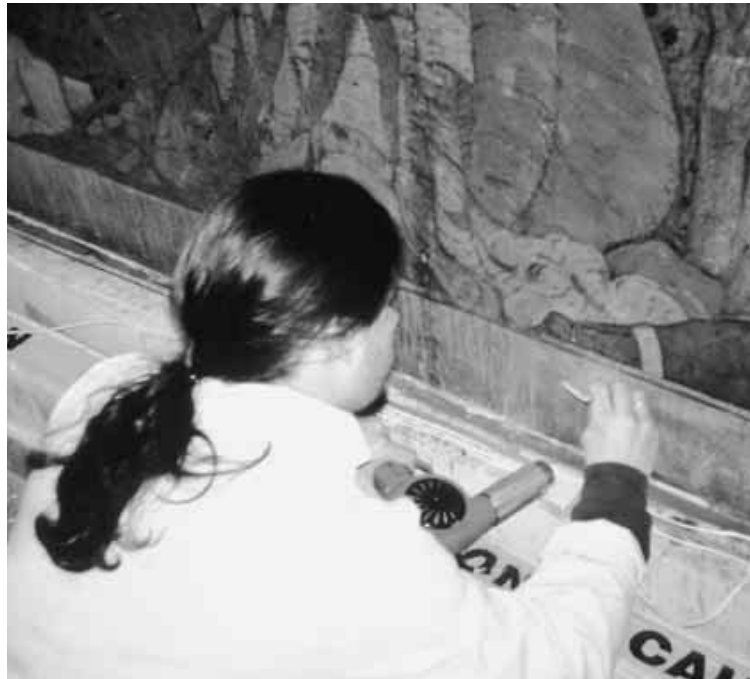
A conservator on the team of Cunningham-Adams Fine Arts Painting Conservation treats the north mural. Photo by the author.

presses of a solution of one part ethyl alcohol and one part lacquer thinner, allowed to dwell for two minutes. The cracked and lifting paint and ground layers were then pressed back into place, inch by inch, and then consolidated with multiple applications of microcrystalline wax (at 5%, 7.5%, and 8%), followed by multiple applications of methylacrylate resin (Acriloid B72; at 5%). This process not only re-adhered the lifting paint and ground to the surface, but re-saturated the colors as well. The re-saturation process is similar to waxing or oiling dry wood, where the grain and luster of the original material returns as its surface becomes wet. Even with the first applications of the wax, the results were extremely dramatic. The original colors and subject matter were brought back to life, showing how the artist and architect intended the interior of the memorial to be experienced. Before treatment, many original features were obscured. After treatment, even the red rouge of a little girl in the north mural is visible.
